Development of Transient Earth Voltage Sensor for Partial Discharge Detection in Gas-insulated Switchgear

Keywords: gas-insulated switchgear, transient earth voltage, sensor, partial discharge

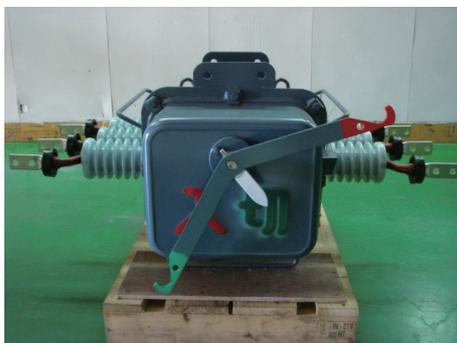
Fig. 1. (Color online) SF₆ line load switch on rod.

GIS is a high-voltage-level metal-enclosed switchgear filled with SF₆ insulating gas. As one of the GISs, the pole-mounted load break switch (PMLBS) is a three-phase and three-wire GIS. PMLBS is manufactured with SF₆ gas and sprayed sleeve arc elimination to avoid arcing and insulation damage.⁽⁴⁾ Figure 1 shows the load switch made of stainless steel. Its flat structure is to avoid corrosion by rain and acid. The internal contacts and components are insulated with SF₆. It does not require regular maintenance. However, when the SF₆ gas pressure is not sufficiently high to protect the switch, the operation is stopped to avoid accidents. This allows for long life, high reliability, and weather resistance.

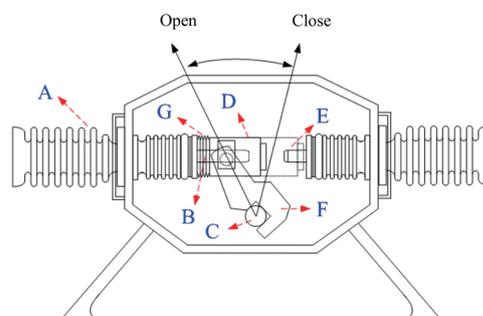
The internal structure is shown in Fig. 2, which presents the line load opening and closing switch. The opening and closing of the load switch are operated by moving the insulating arm on the linking shaft.⁽³⁾ The arc generated during the opening and closing is extinguished by the movable contact and blowing SF₆. Then, the internal insulation is protected from the arc and the deterioration of the insulation is avoided.⁽¹²⁾ Otherwise, the arc affects the insulating ability and the normal operation of the load switch. The load switch contains a porcelain casing, a fixed electrode rod, a connecting shaft, a movable contact, a fixed contact, an insulated operation arm, and a blowing cylinder.

Fig. 2. (Color online) Internal structure of SF₆ line load switch.

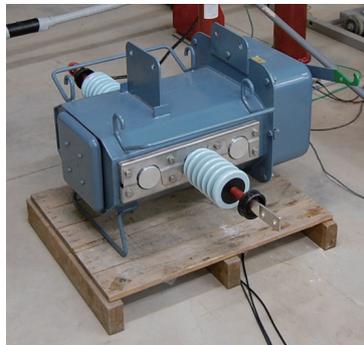
Fig. 3. (Color online) Photo of load switch.

Other than metal particles inside the case of the load switch, defects are also found in the internal switch and mechanical structure, which are not found easily by manual inspection. We used a three-phase 15 kV rod-type SF₆ line load switch in the experiment. Defects are frequently found in the load switch, such as oil stains in the porcelain casing on the load side, metal particles in the case, foreign objects on the connecting shaft, metal protrusions on the ring of the load switch, and metal fatigue on the load and highly pressurized sides. Figure 3 shows a photo of the load switch. Figures 4–7 depict the various defects of the load switch. The analysis of the structure of the single-phase load switch can help to avoid the partial discharge caused by various defects. These defects can be found in each situation caused by a defect.

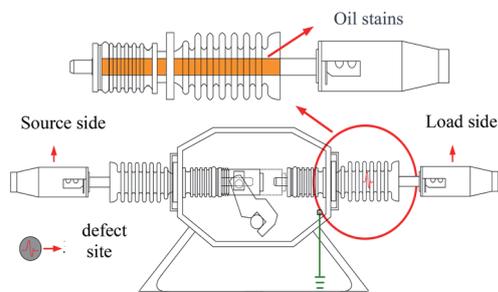
Fig. 4. (Color online) Oil stains in porcelain casing on the load side.

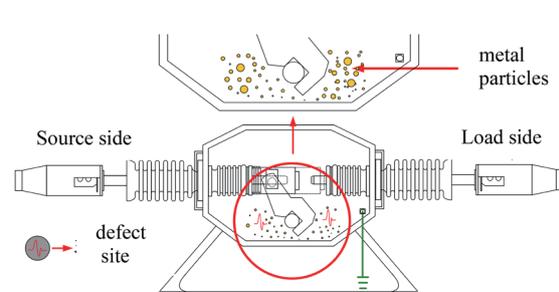
Fig. 5. (Color online) Metal particles in connecting shaft.

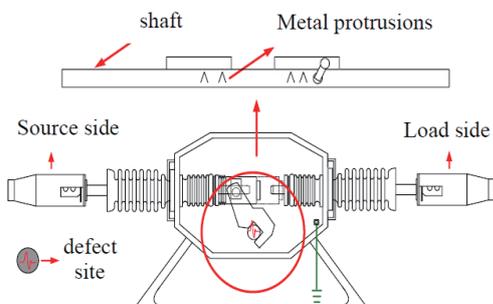
Fig. 6. (Color online) Metal protrusions on connecting shaft.

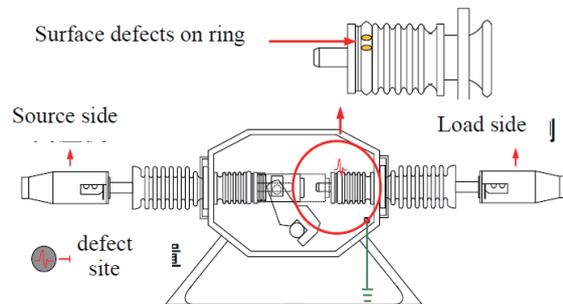
Fig. 7. (Color online) Metal fatigue on load and source sides.

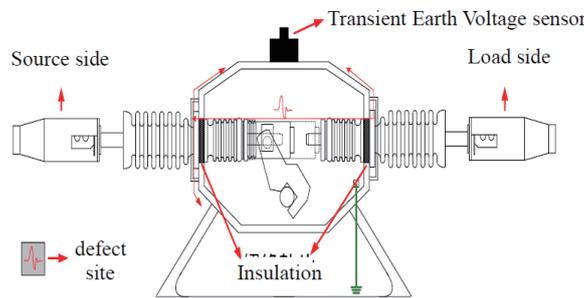
The TEV detection method requires a capacitive sensor to detect partial discharge. When the partial discharge is generated, the voltage and current propagate along the metal casing and spread on its surface to be earthed in the gap between the opening and the inside as shown in Fig. 8.⁽¹³⁾ The voltage is only changed from a few millivolts to volts in nanoseconds, so the signal range of TEV is limited.⁽¹⁴⁾

Fig. 8. (Color online) TEV detection method.

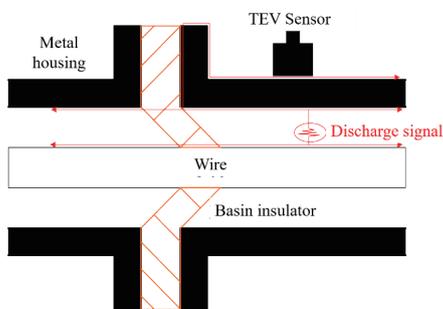
When partial discharge occurs inside the load switch, the discharged current gathers on the internal surface of the metal casing and its signal propagates to the surface. Through gaps at the connection and insulation parts, the TEV is generated on the ground rod as shown in Fig. 9.^(15,16)

Fig. 9. (Color online) Occurrence of TEV.

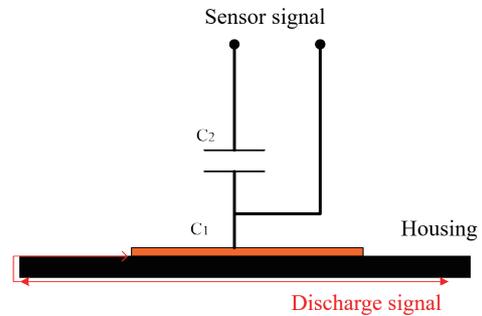
According to the principle of TEV generation, the metal casing becomes an electrode, a silicone sheet is an insulating medium, and a copper sheet is a capacitor C_1 . The discharge signal is obtained on both ends of capacitors C_1 and C_2 . From the theory, the larger the surface area of the copper sheet, the larger the value of C_1 , and the better to detect the partial discharge signal (Fig. 10).

Fig. 10. (Color online) Diagram of TEV sensor.

Here, ϵ_r is the dielectric constant of the silicone film and ϵ_0 is that of the vacuum. The size of GIS is considered assuming that GIS is circular. When the area of the copper sheet is very large, the silicone sheet must have a corresponding area that is impossible.

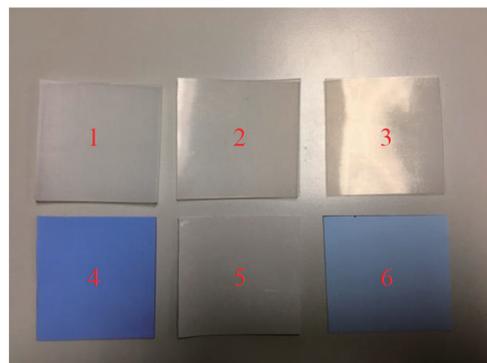
Figure 11 shows the six different silicone sheets used in this study, which are cut into squares with a side length of 5 cm. The first, second, and third silicone sheets have the same transparent color but with different thicknesses (3, 2, and 1 mm, respectively). The fourth silicone sheet has a dark blue color and a thickness of 2 mm. The fifth silicone sheet has a gray color and a thickness of 1 mm, and the back side is glued to adhere to the surface easily. The sixth silicone sheet has a blue color and a thickness of 0.3 mm.

Fig. 11. (Color online) Different silicone sheets used in this study.

After obtaining the dielectric constants of the silicone sheets, the capacitance C_1 was calculated and the capacitance C_2 was selected. The original amplifier signal was projected back after measuring the signal. The first, fifth, and sixth silicone sheets were very thin, so it was impossible to make them stick to the metal casing, whereas the fourth silicone sheet was soft and its ductility was not good so it could easily be cracked and damaged.

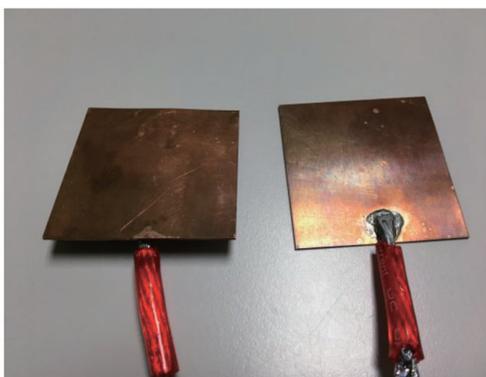
The dielectric constants of the silicone sheets are measured by placing a square of the sheet with a side length of 5 cm in the middle of two thin copper square sheets of the same size to form a capacitor. The copper sheet is shown in Fig. 12.

Fig. 12. (Color online) Copper sheet.

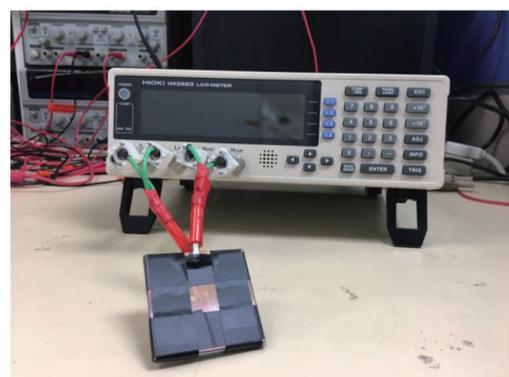
To make the copper sheet fit to the silicone sheet and not have gaps between the sheets, tape is used to ensure that there are no air gaps in the middle. Then, the HIOKI_IM3523 LCR METER is used to measure capacitance as shown in Fig. 13. The dielectric constant of the silicone sheet was calculated by the method described in Ref. 1, and the results are shown in Table 1.

Fig. 13. (Color online) Measurement of capacitance.

Silicone sheet	Thickness (mm)	Dielectric constant
1	3	3.278492099
2	2	3.046925508
3	1	2.67468716
4	2	4.490455982
5	1	3.008848758
6	0.3	1.4668307

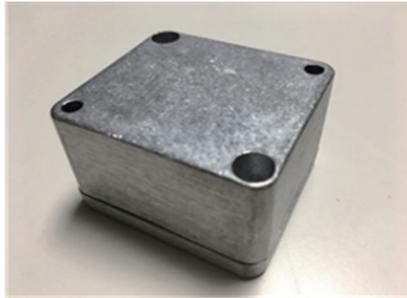
The TEV sensor shell was made of aluminum, which can shield the external interference signal. The TEV sensor casing was made of aluminum ($50 \times 45 \times 30 \text{ mm}^3$) as shown in Fig. 14. The sensor did not have direct contact with the metal housing of the load switch to avoid a leakage of current when the metal housing had a leakage current. The BNC connector was inserted and fixed on the sensor. C_1 and C_2 were connected in series and fixed inside the aluminum box, and then the silicone sheet was glued on. The diagram of the TEV sensor is shown in Fig. 15.

Fig. 14. (Color online) Aluminum housing of TEV sensor.

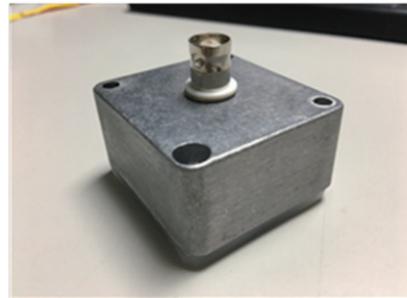
Fig. 15. (Color online) Photo of TEV sensor.

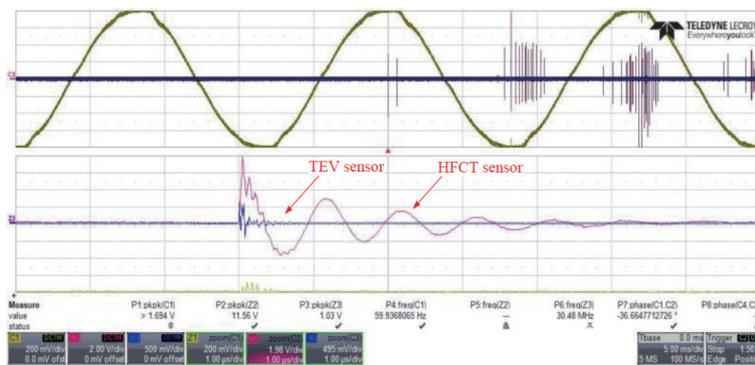
To verify the operation of the TEV sensor, we used it for silicone sheets of different thicknesses and high-frequency current converters (HFCTs) to detect the partial discharge for comparison. Figure 16 shows the results of the TEV and HFCT sensors for the second silicone sheet of 2 mm thickness. The yellow line is for the applied voltage signal, the red line is for the HFCT detection signal, and the blue line is for the TEV sensor detection signal. Although the discharge signal was detected at the same time point, the frequency of the signal detected by the TEV sensor was about 30 times higher than that detected by the HFCT sensor. The bandwidth of the TEV sensor was higher than that of the HFCT sensor, whereas the amplitude of the HFCT sensor was higher than that of the TEV sensor.

Fig. 16. (Color online) Measurement results of discharge with TEV and HFCT sensors for silicone sheet of 2 mm thickness.

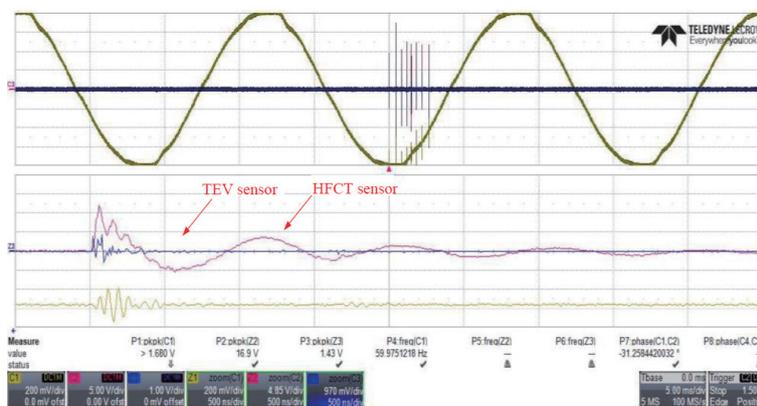
Figure 17 shows the measurement results of discharge with the TEV and HFCT sensors for the silicone sheet of 3 mm thickness. The oscillation frequency of the signal detected by the TEV sensor was higher than that detected by the HFCT sensor. The detection time of the TEV sensor was shorter than that of the HFCT sensor as the latter was used as an inductive sensor, and thus, its inductance took a longer time. The amplitude of the signal detected by the HFCT sensor was higher than that detected by the TEV sensor. The reason was that the propagation direction of the partial discharge was random, which led to energy loss and differences in TEV. In applications, the TEV sensor can be installed more easily than the HFCT sensor.

Fig. 17. (Color online) Measurement results of discharge with TEV and HFCT sensors for silicone sheet of 3 mm thickness.

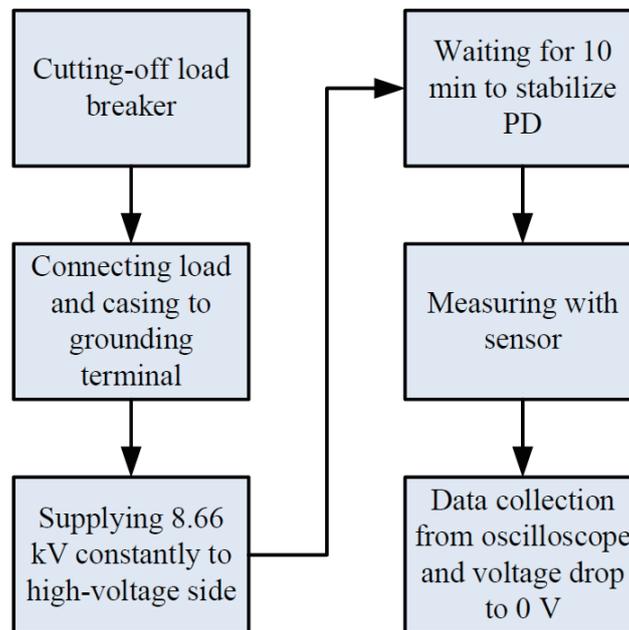
the standard operation. Figure 18 shows the standard load switch test procedure IEC 60044-2-2003 and TPC C039 specification, as well as the test conditions and test flow diagram of this study.

Fig. 18. (Color online) Test procedure.

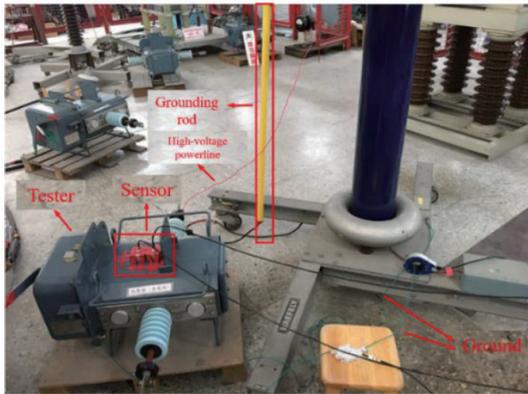
To simulate the discharge caused by GIS faults, an offline test was conducted. In the simulation, special care must be taken and a certain distance must be kept from the oscilloscope, so a relatively long cable was used. The TEV sensor was fixed with electrical tape to make the gap between the sensor and the GIS casing smaller and increase the accuracy of the sensor because the sensor needed to be in close contact with the GIS metal casing (Figs. 19 and 20).

Fig. 19. (Color online) Off-line test platform.

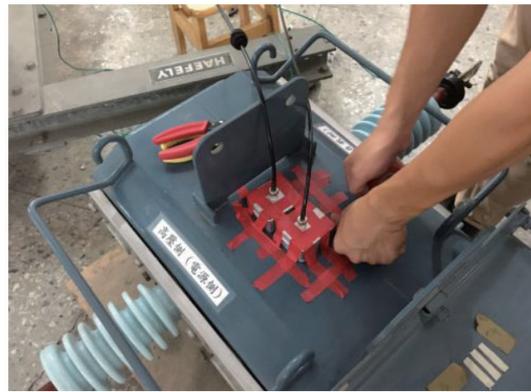
Fig. 20. (Color online) TEV sensor fixed on GIS.

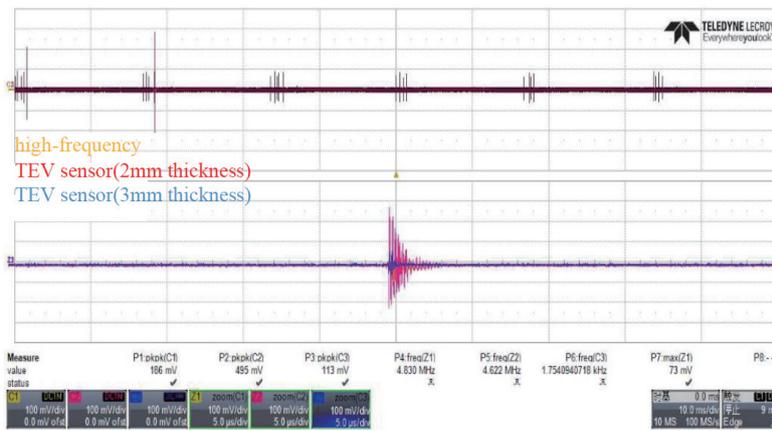
The partial discharge was measured in the complete partial discharge waveform as shown in Fig. 21. The oscillation caused by the TEV sensor after detecting the discharge signal is the inductive nature of the transmission line showing the high frequency of the signal. Figure 22 shows that the best signal among the separated three signals was measured by the TEV sensor with a silicone sheet of 2 mm thickness.

Fig. 21. (Color online) TEV sensor detection results.

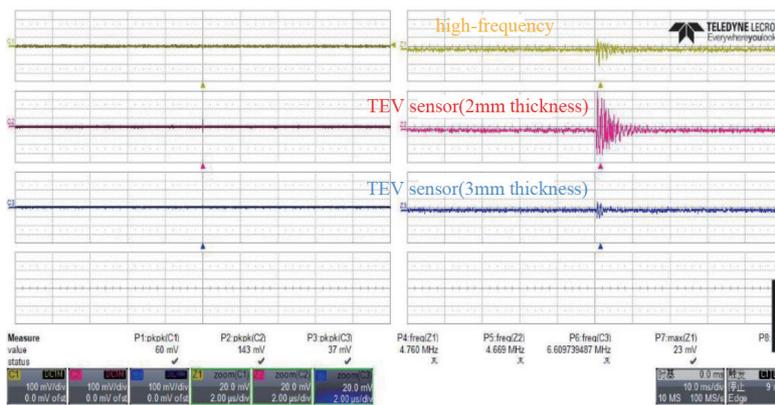
Fig. 22. (Color online) Test result of TEV sensor.
